Former Lower Burning Ground RAB Presentation October 24, 2013

Picatinny Arsenal

RAB UPDATE

Mid Valley Groundwater

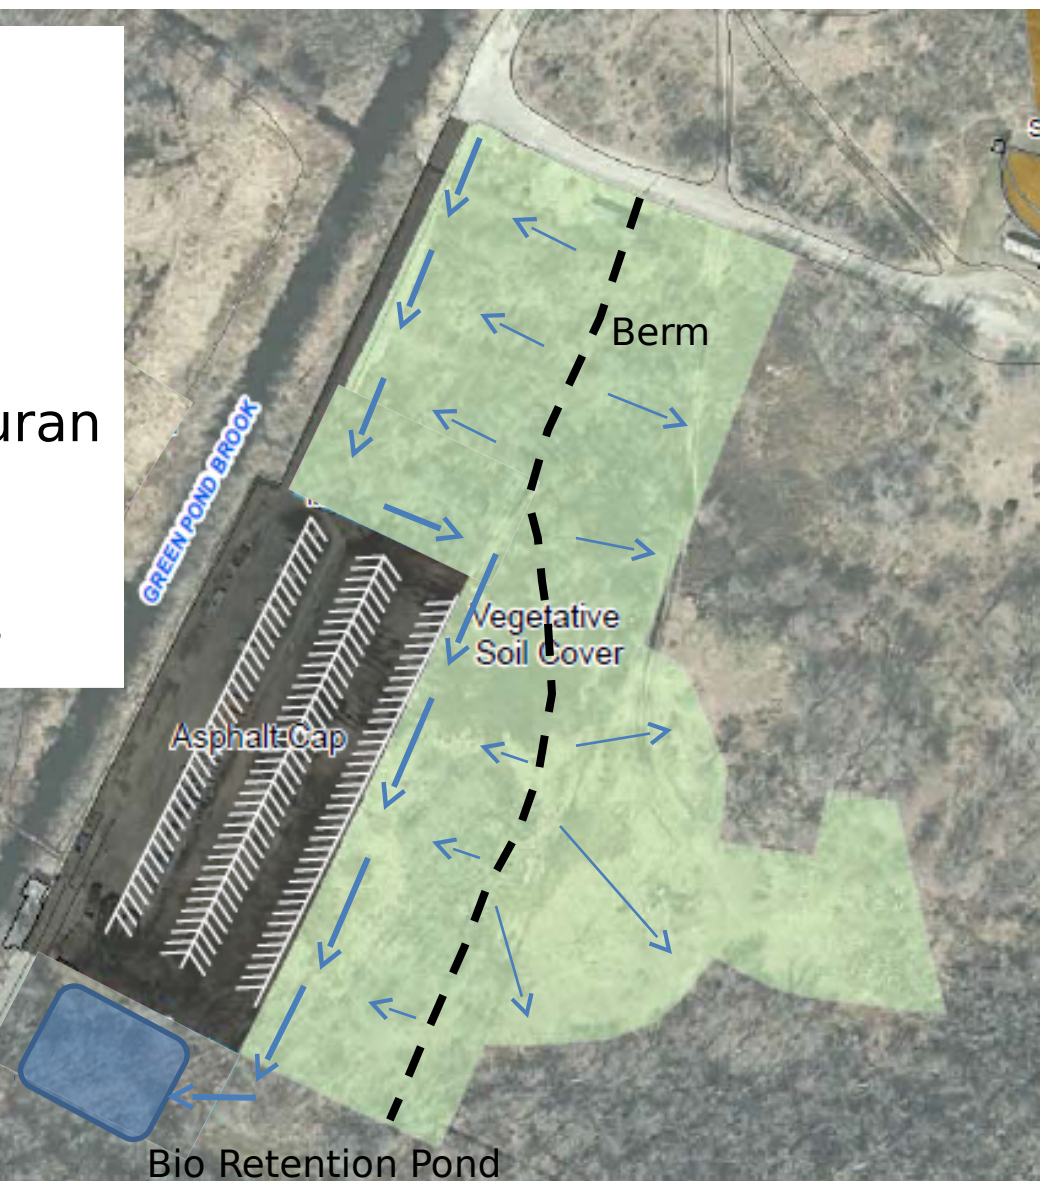
Asphalt Cap:

1. Caps most contaminated area
2. Caps 11 highest lead concentrations
3. Caps the highest dioxin/furan concentration
4. Located next to (and upgradient of) the 3 wells with MCL exceedances

<u>Asphalt Cap</u>	<u>Soil Cover</u>
Max. lead conc.	15,800	1,590
Ave. lead conc.	2,405	527
Concentrations in mg/kg (ppm)

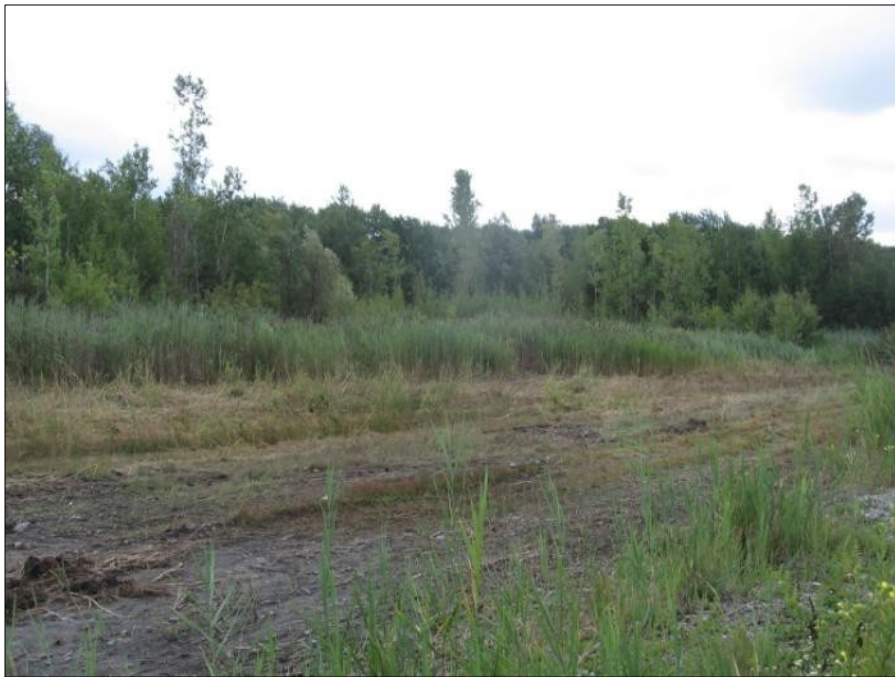
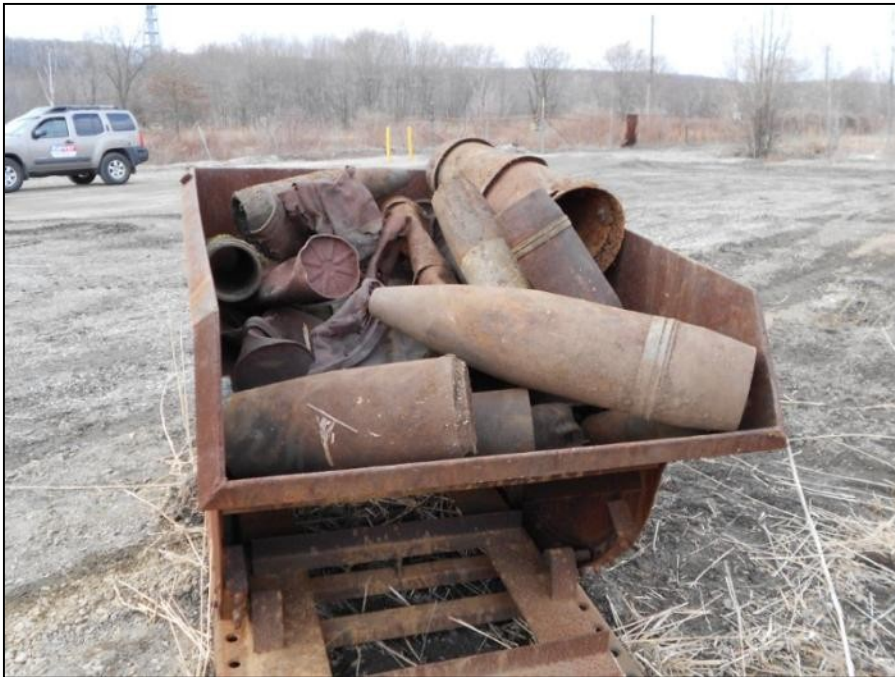
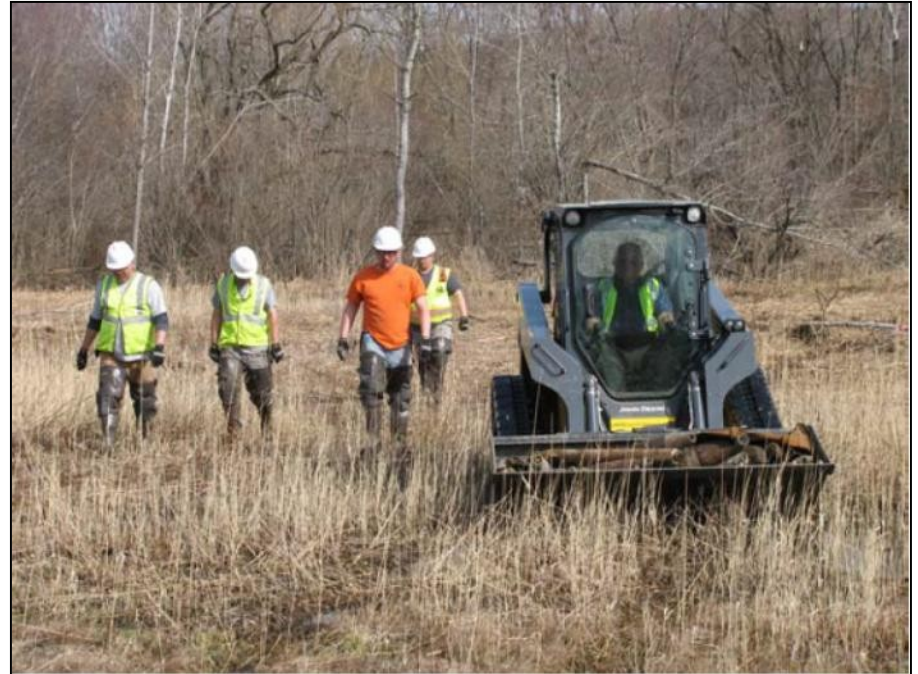
90% complete

- Re-cut brush that has re-established
- Remove trees in area of bio-retention pond

Photos: Lower Burning Ground 2012

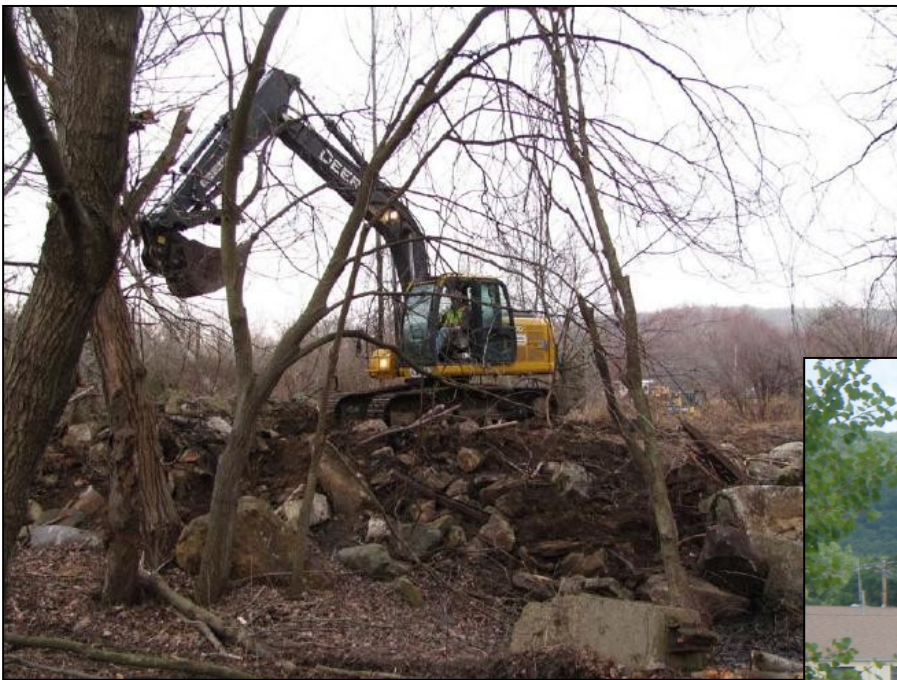
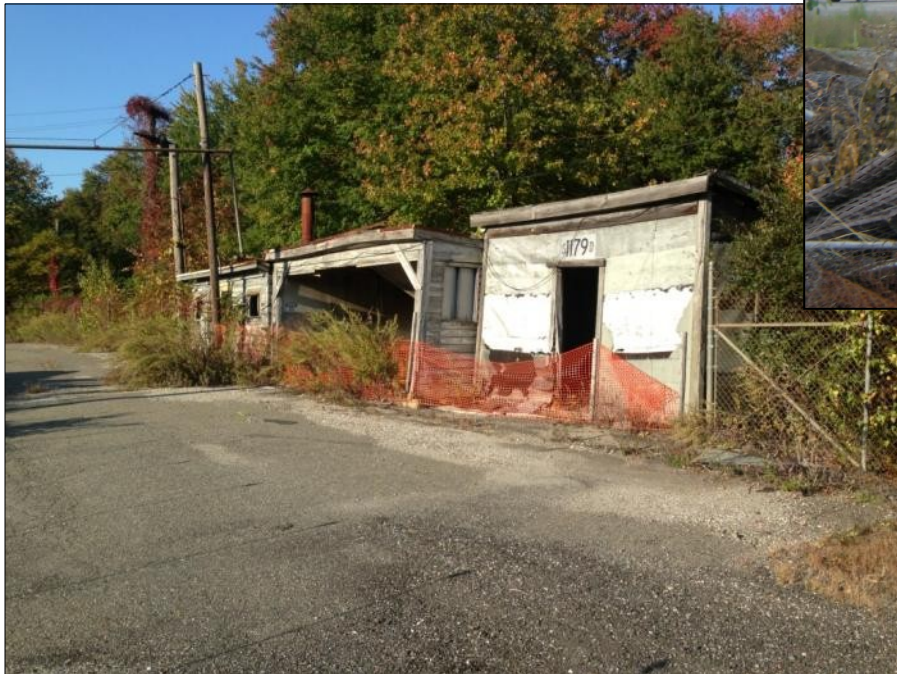
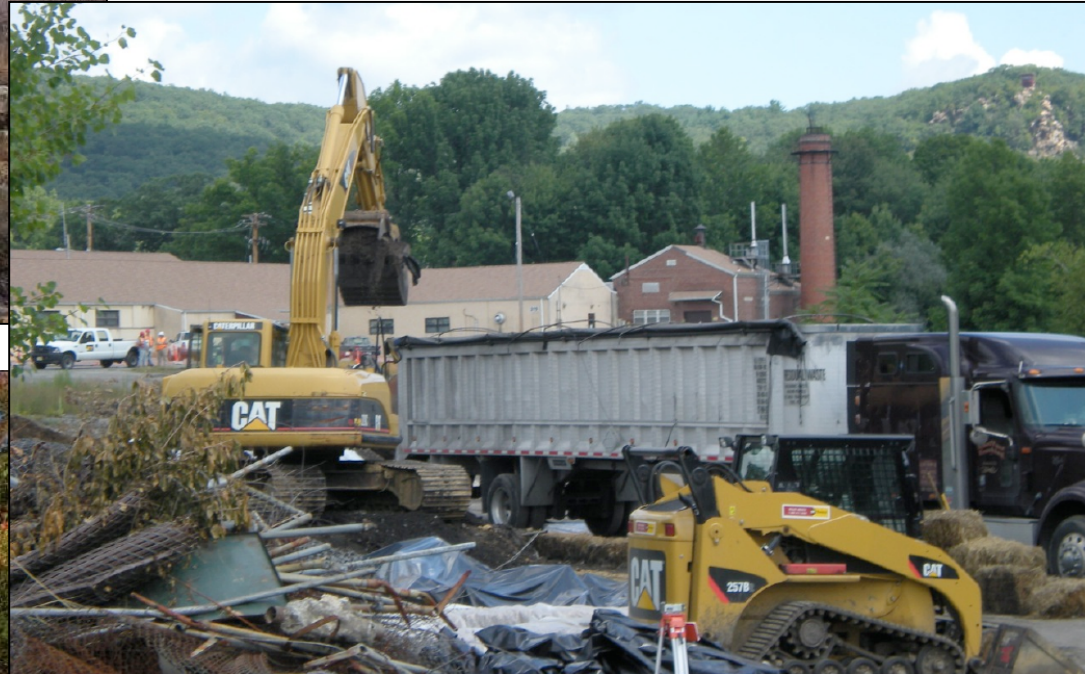
- Remove debris from site to allow capping
- Large surface debris
 - Existing buildings
 - Remove for off-site disposal

Photos: LBG 2012/2013 (2 photos to left)
and debris load out at an
ARCADIS/Army project site (photo on
right)

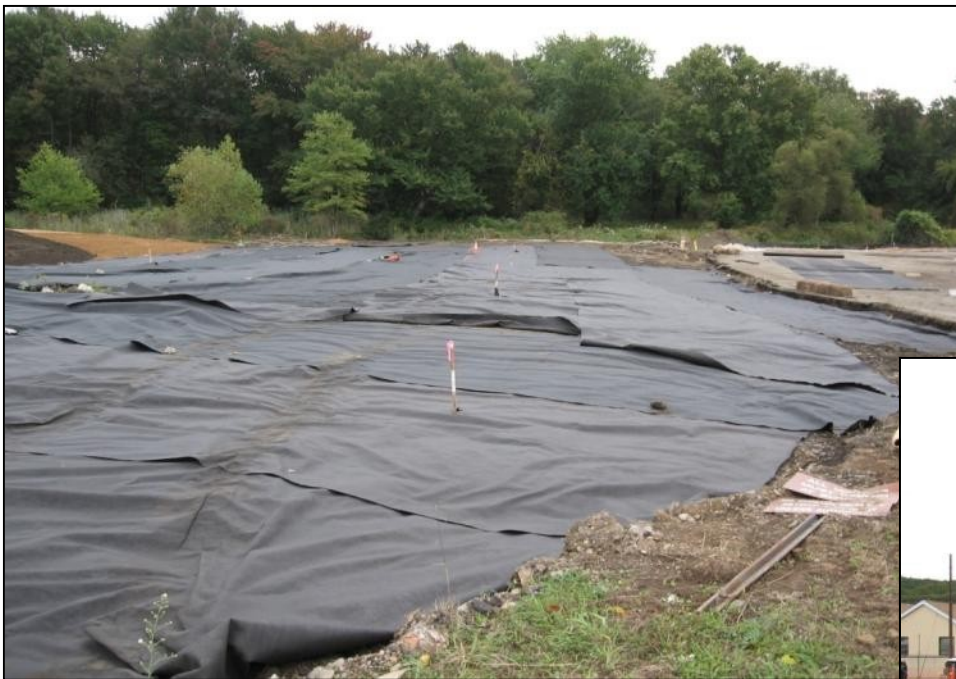
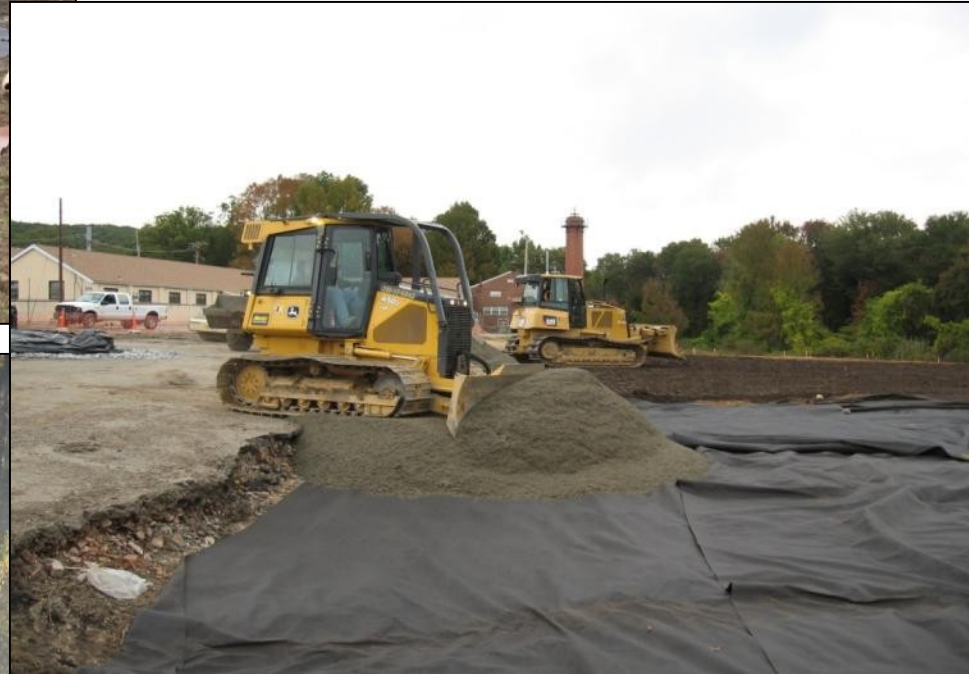
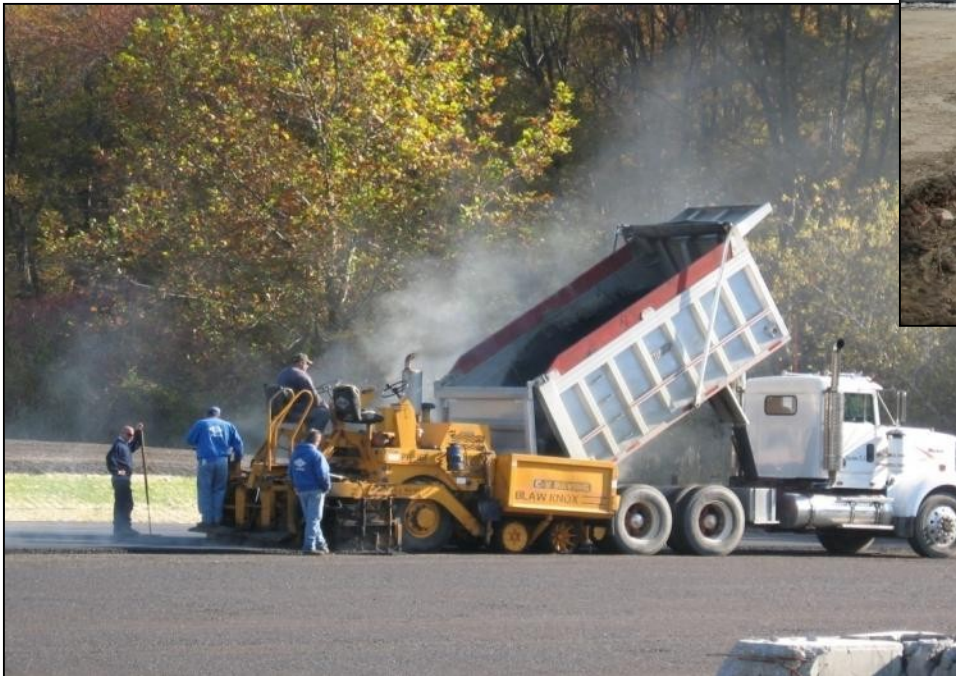
2 Acre Asphalt Cap

- Geotextile fabric
- 12 inch gravel subbase
- 4 inch hot mix asphalt

Photos: DRMO in 2009

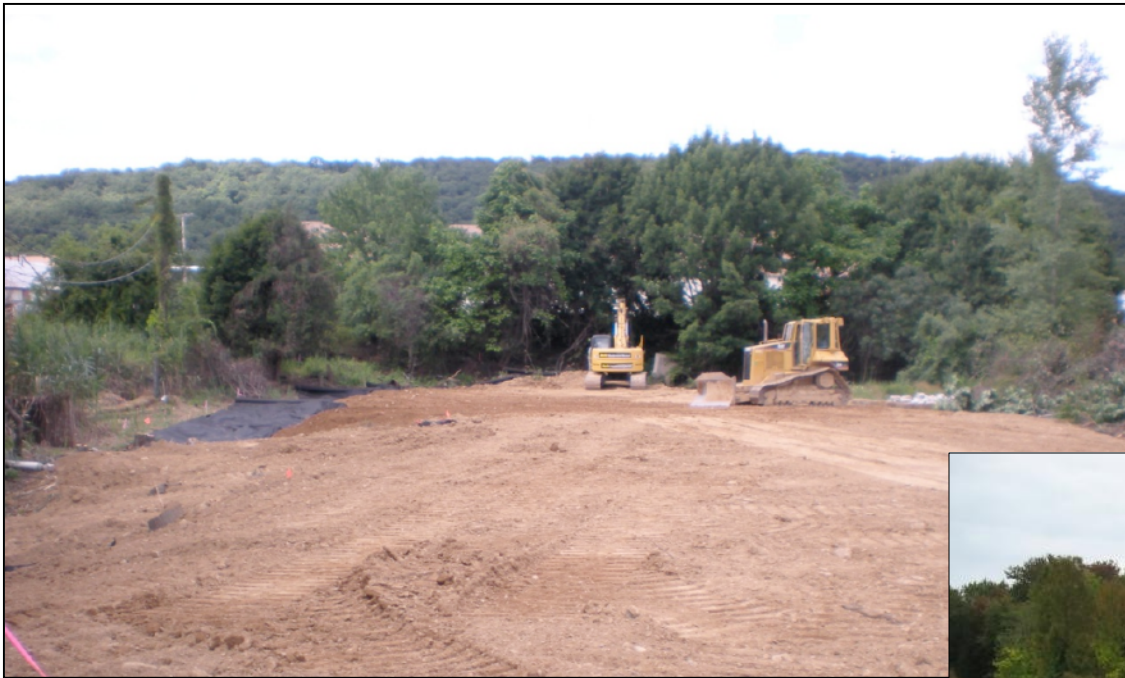
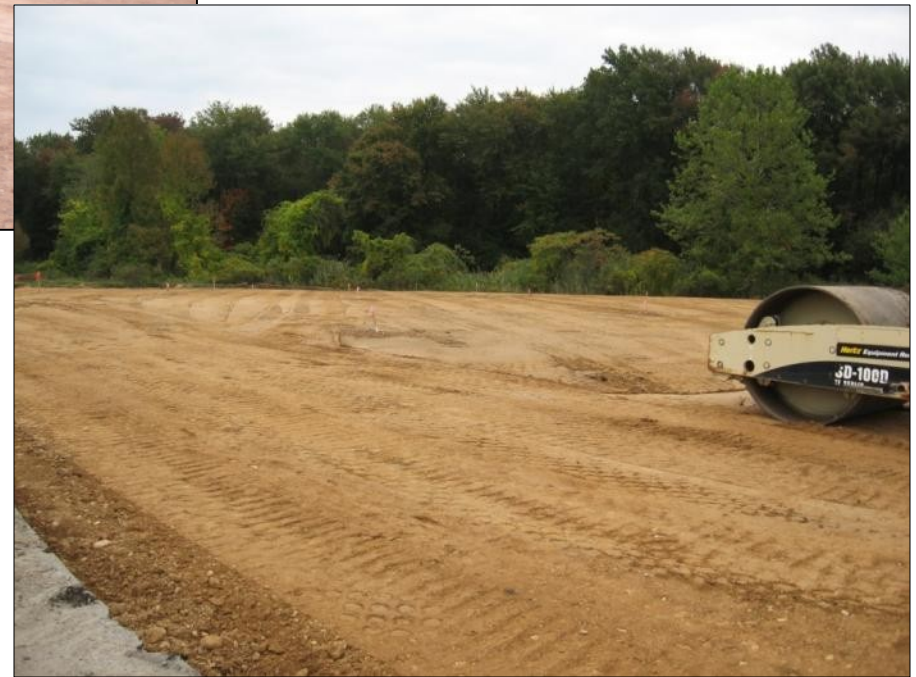
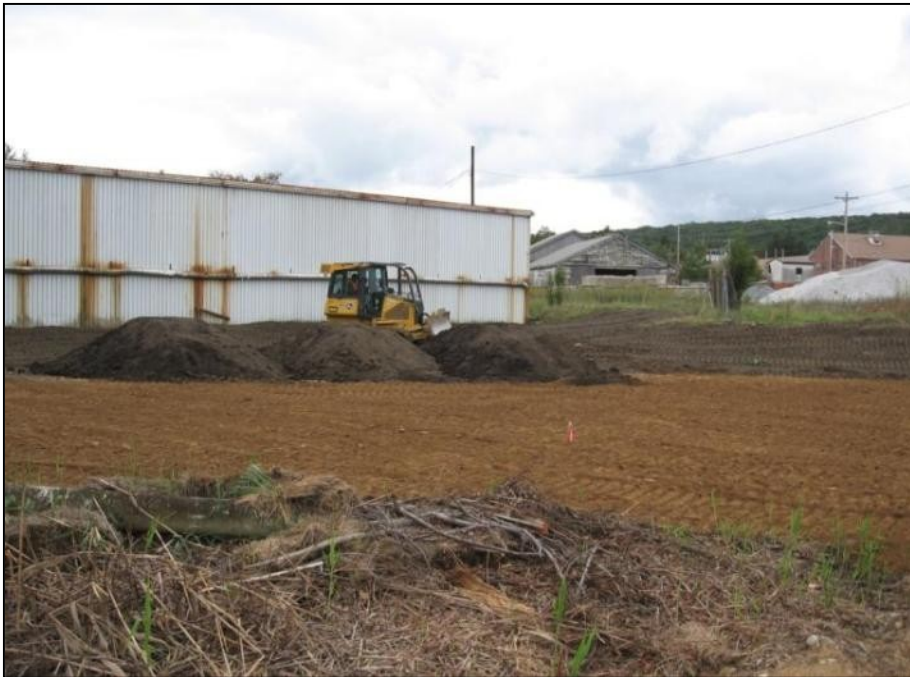
6 Acre Soil Cover

- Geotextile fabric
- 18 inch soil cover
- 6 inch topsoil layer

Photos: DRMO in 2009

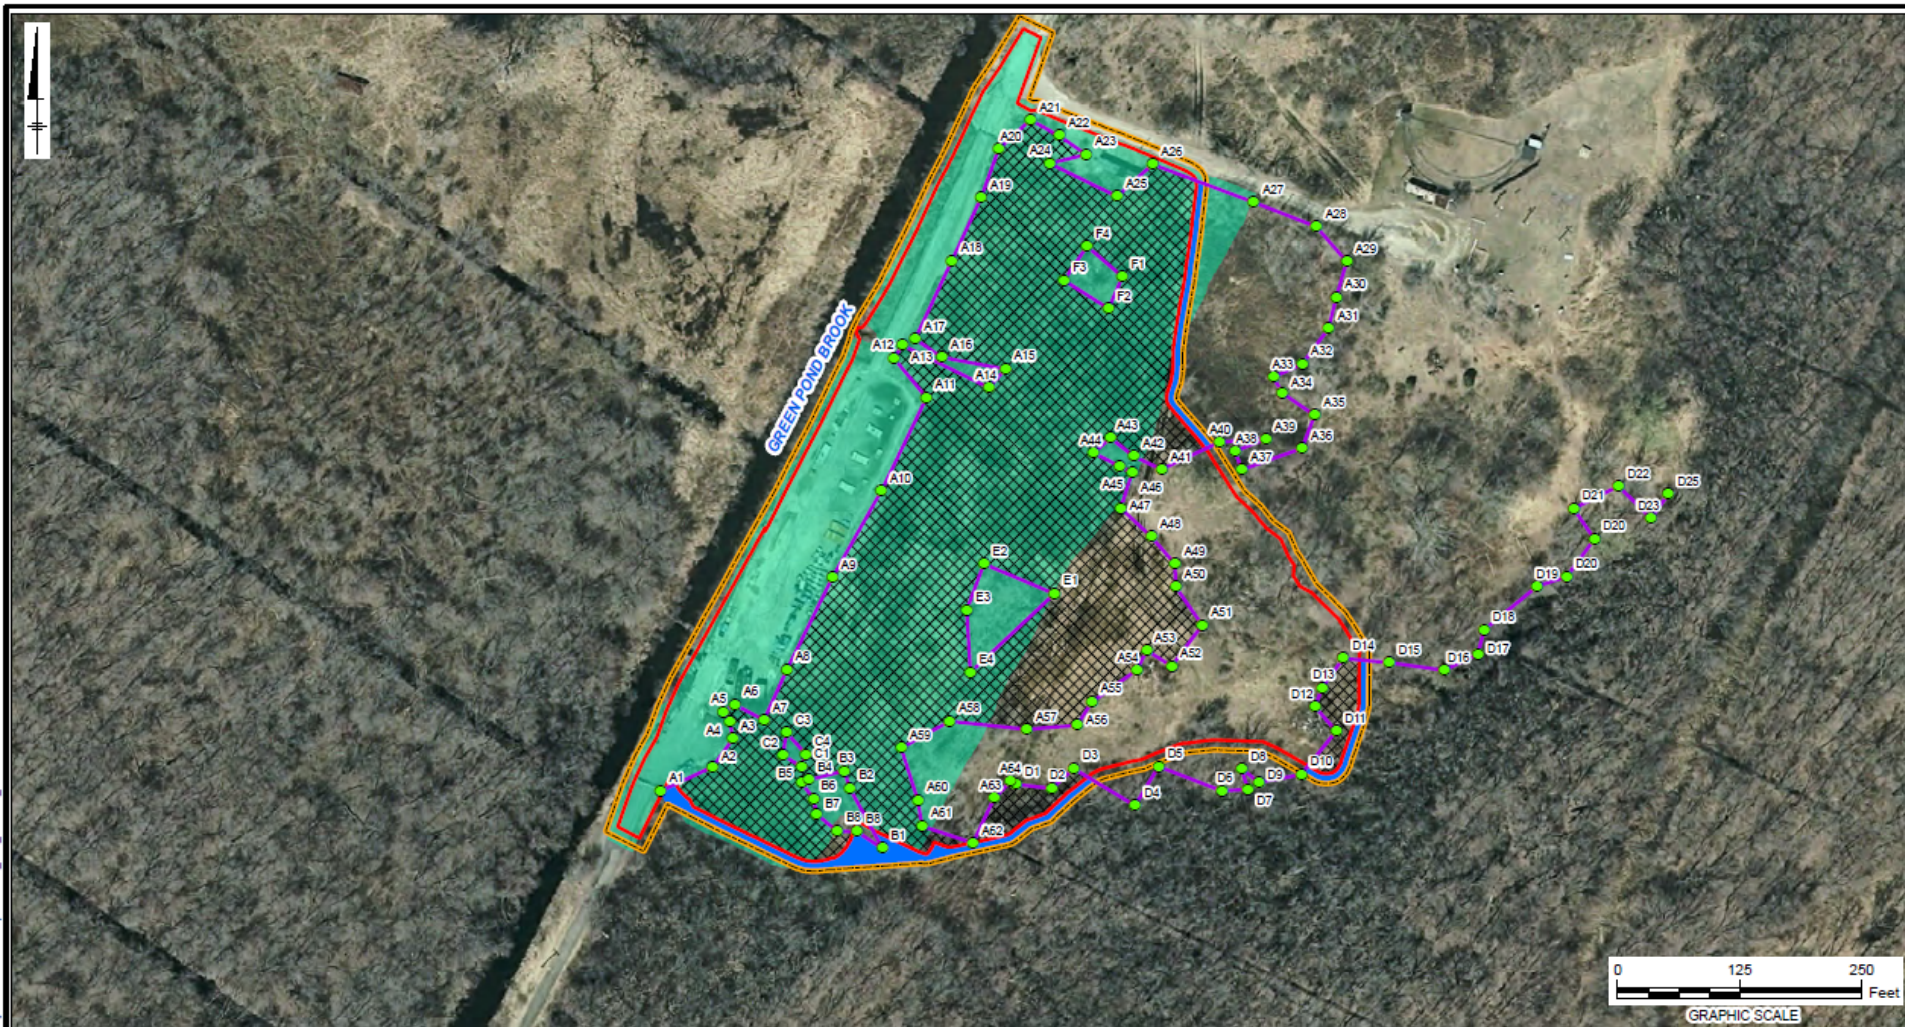
FIGURE
3

1. RIPARIAN ZONE IS MEASURED AS 300 FEET FROM TOP OF BANK BASED UPON CONDITIONS OF N.J.A.C. 7:13-4.1(c) AND THE FACT GREEN POND BROOK IS LISTED AS A CATEGORY ONE WATERWAY AND A TROUT PRODUCTION STREAM UNDER N.J.A.C. 7:9B - SURFACE WATER QUALITY STANDARDS.

2. WETLANDS DELINEATED BY ARCADIS ON OCTOBER 18, 2012.
3. LIMITS OF PROJECT DISTURBANCE ALONG GREEN POND BROOK ARE CONCEPTUAL. ALL SEDIMENT AND EROSION CONTROL MEASURES WILL BE IMPLEMENTED AT THE BOUNDARY OF THE HYBRID CAP LIMITS TO PREVENT WORK IN FLOODWAY OF GREEN POND BROOK.

4. WETLAND BOUNDARY CONSERVATIVELY ASSUMES A 150 FOOT TRANSITION AREA BUFFER.
5. IMPACTS TO REGULATED AREAS WITHIN THE LIMITS OF REMEDIAL ACTIONS ARE AS FOLLOWS: THE TOTAL PERMANENT WETLAND IMPACTS ARE 4.3 ACRES, TOTAL TEMPORARY WETLAND IMPACT IS 0.2 ACRES, TOTAL TEMPORARY WETLAND TRANSITION IMPACTS ARE 3.3 ACRES, AND TOTAL RIPARIAN ZONE IMPACTS ARE 6.7 ACRES.

SITE PLAN

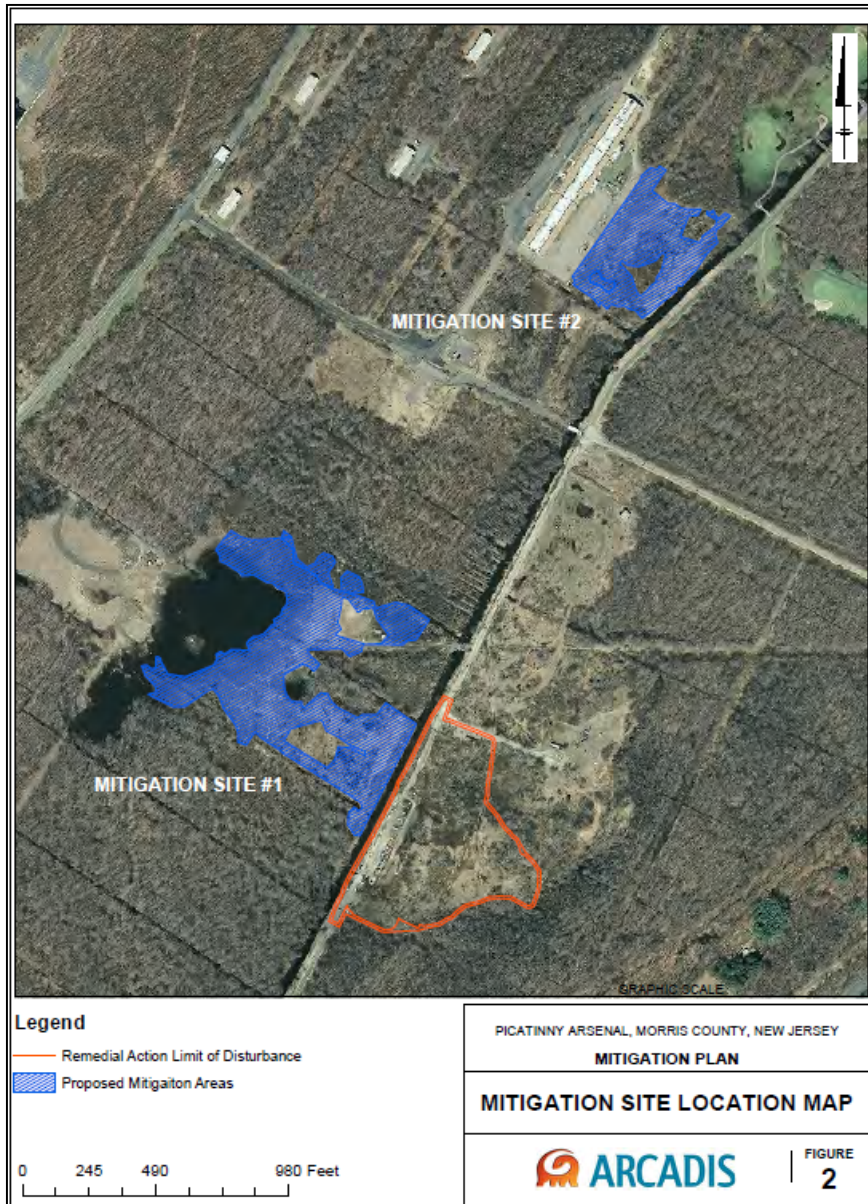
Mitigation Areas

September 2013

Ground application of herbicide

Winter 2013/2014

Mowing of Dead Phragmites (invasive)

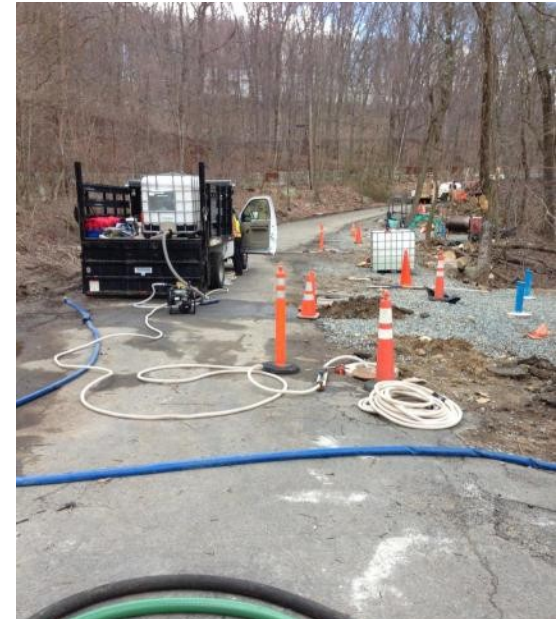
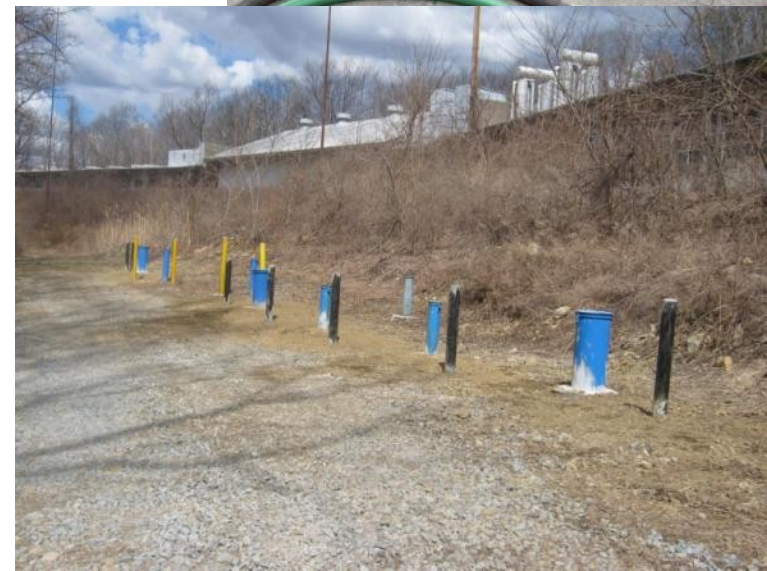
- February – March: Baseline performance monitoring
- March: First EVO injection
- 2 quarterly monitoring events since injection
 - May
 - August
- Already seeing favorable results in several wells
- Next quarterly monitoring event scheduled for November

In-Situ Bioremediation

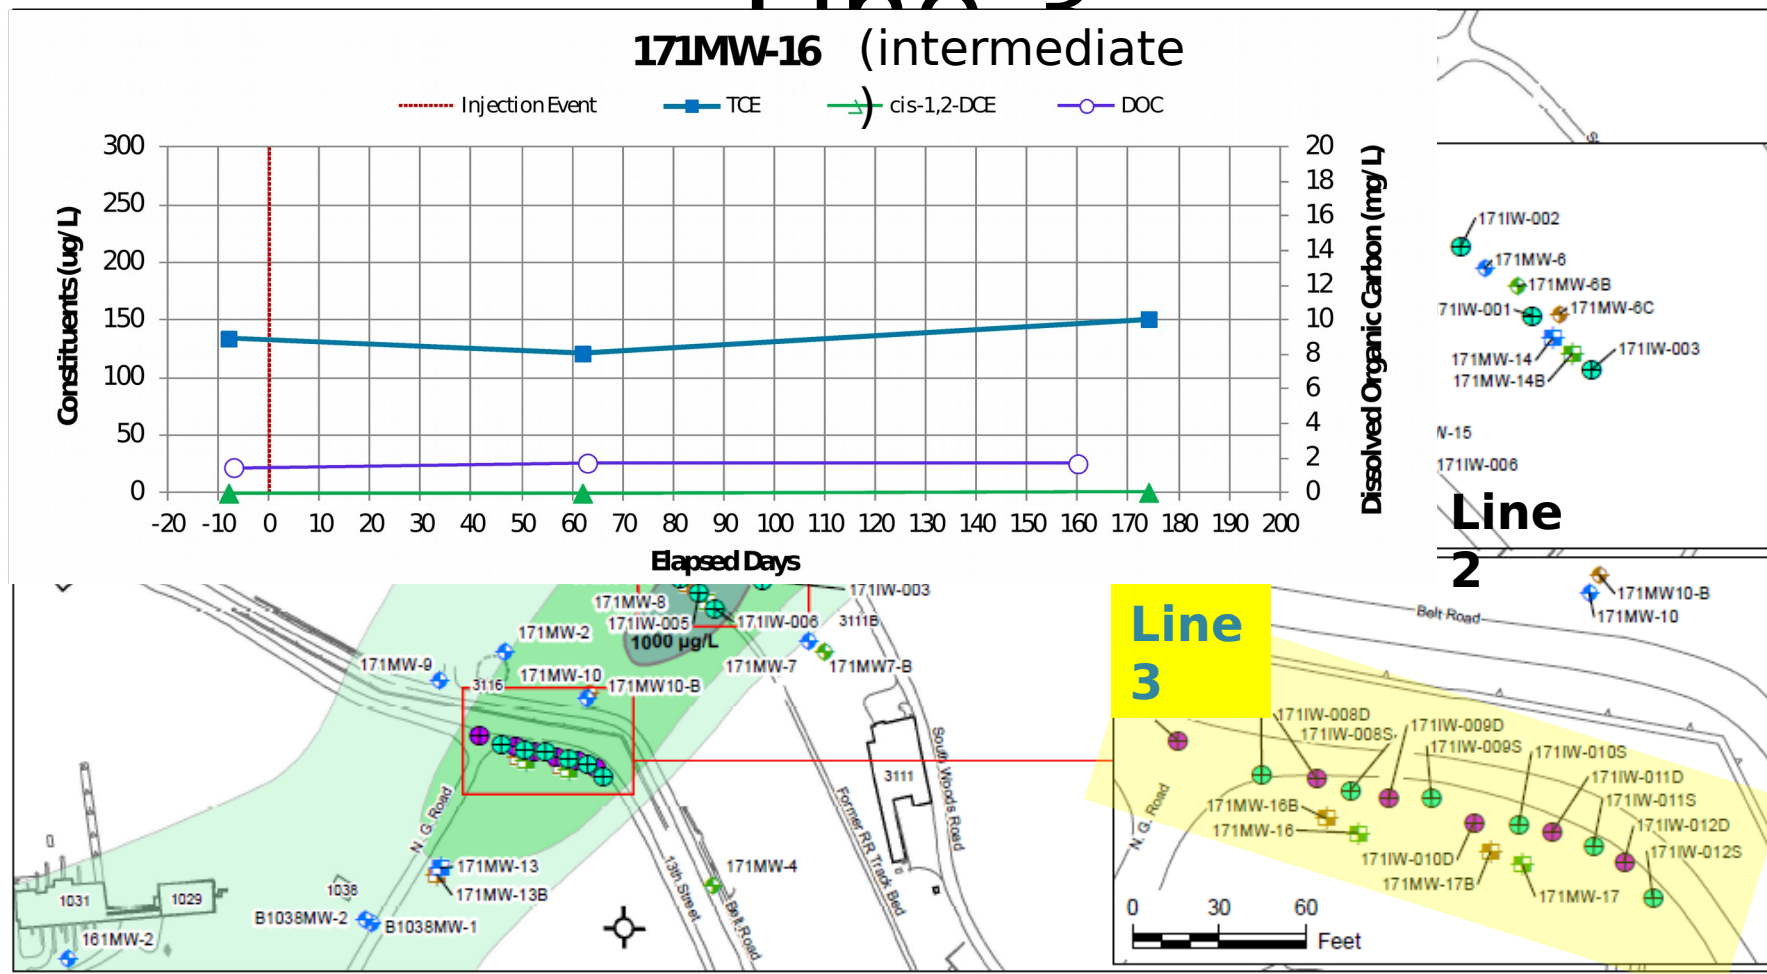
FIGURE
4

MID-VALLEY GROUNDWATER (PICA-204)
PICATINNY ARSENAL, NEW JERSEY

LAYOUT OF FOCUSED
ENHANCED REDUCTIVE DECHLORINATION (ERD)
WELL NETWORK

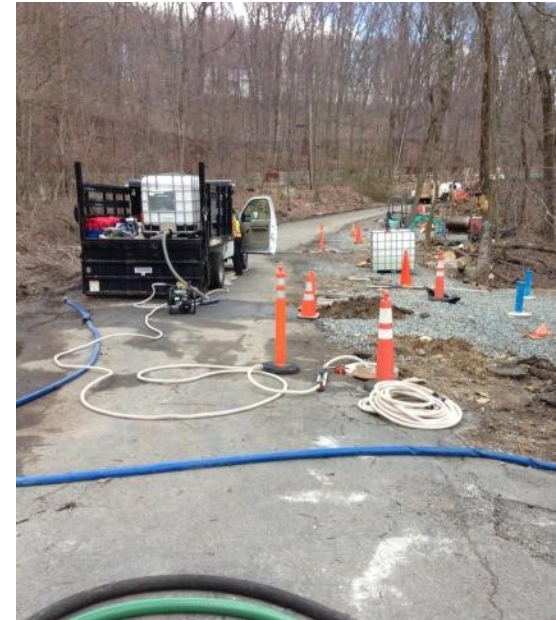
- Early results look favorable
 - Reducing conditions are becoming established.
- TCE decreasing and degrading to cis-1,2-DCE
- Second injection event planned for November to increase carbon loading & accelerate buildup of reducing conditions

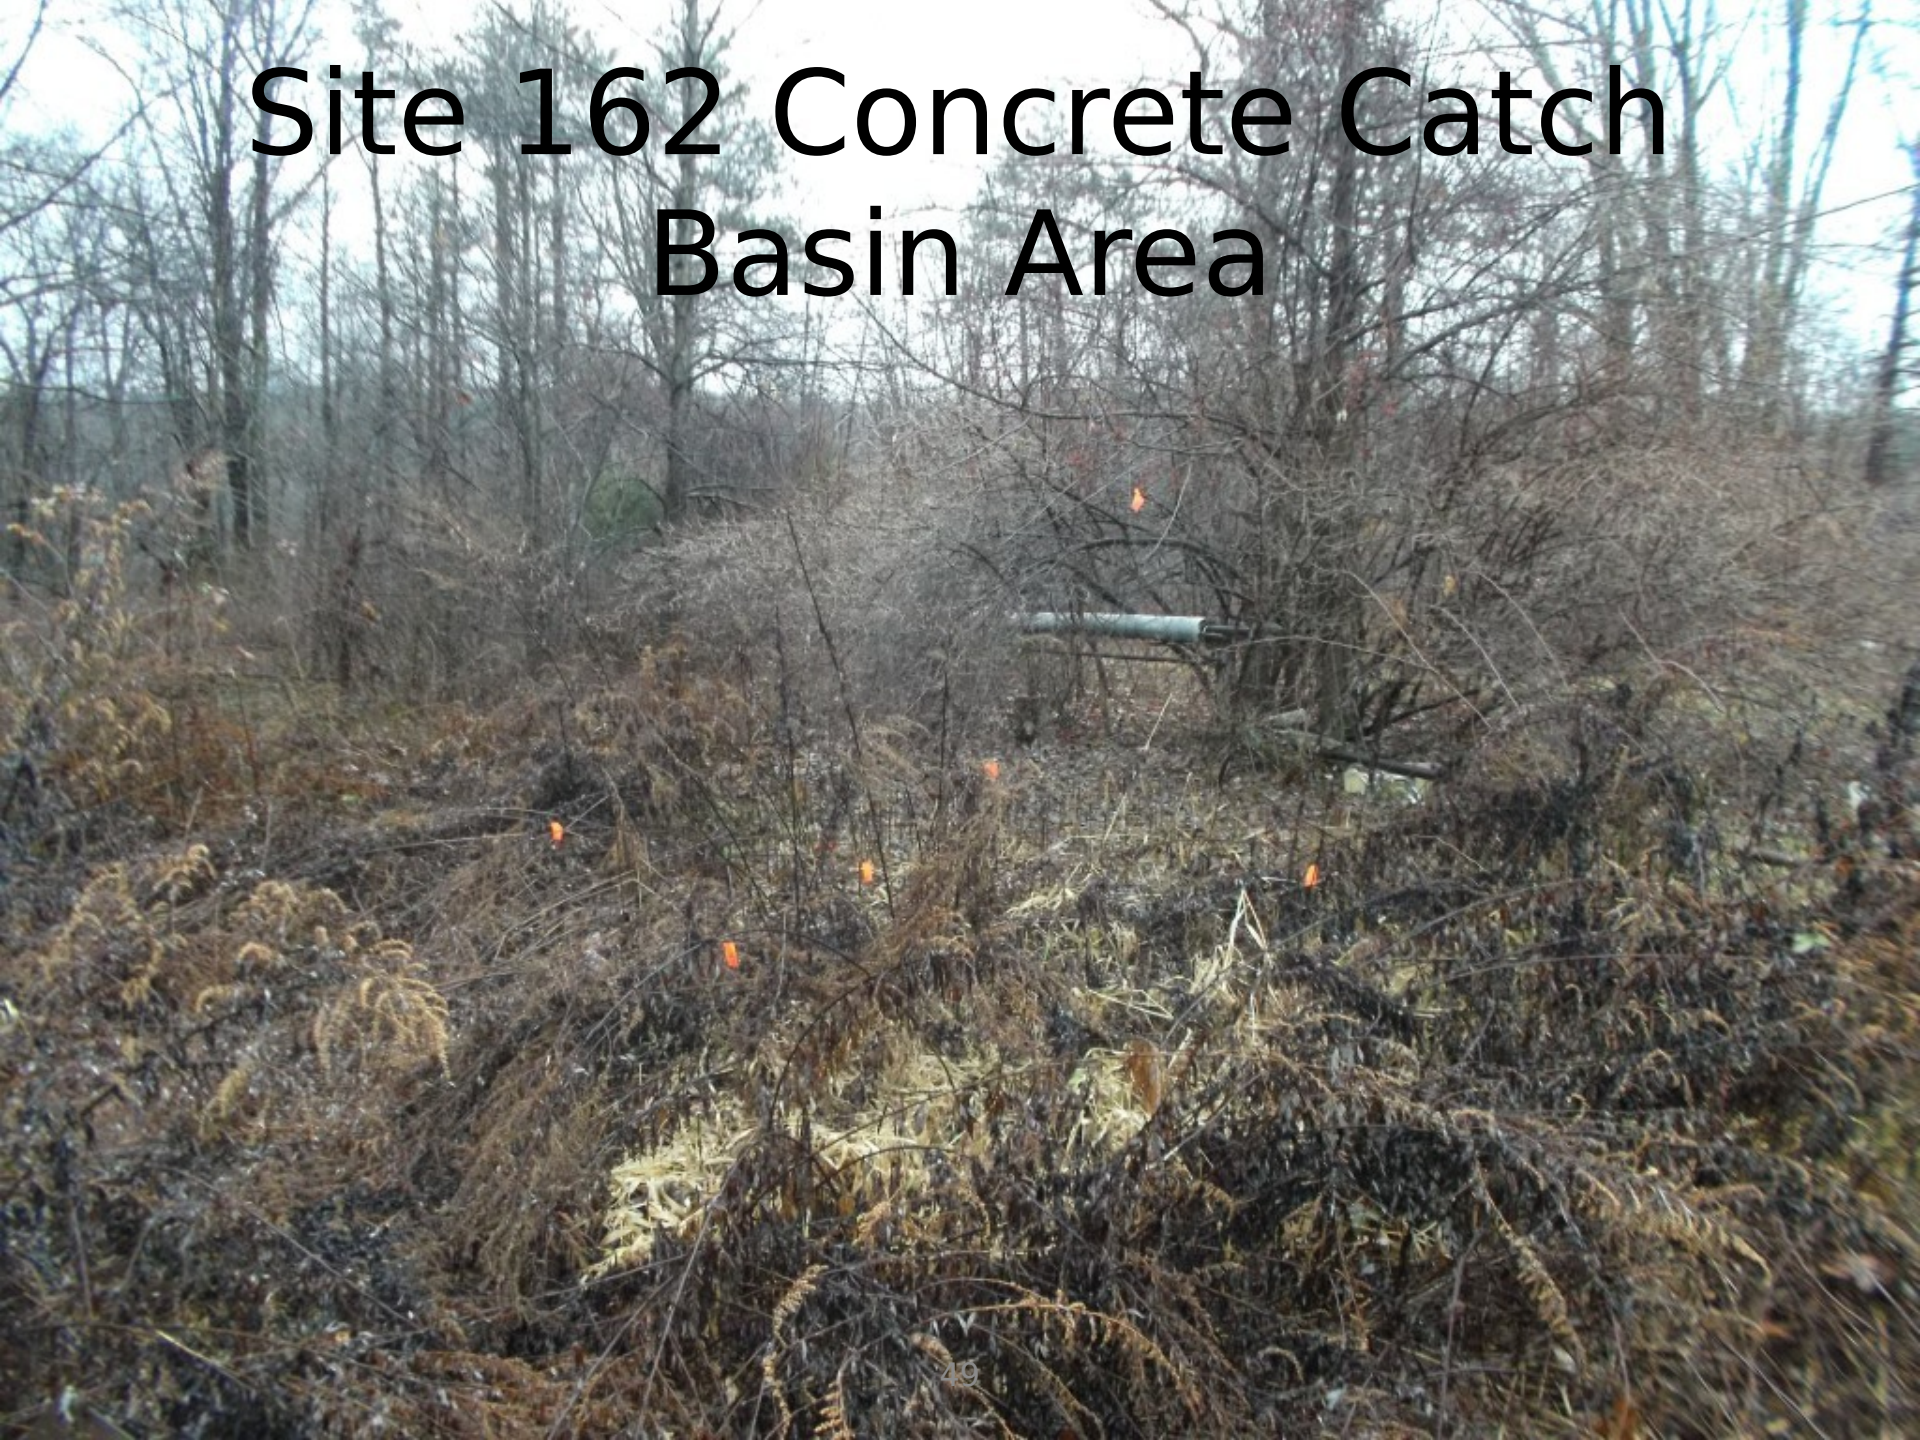
Site 162 Concrete Catch Basin Area

- Probable source area for RDX plume (near well 17MW-5)
- Former waste water conveyance area associated with explosives production
- RDX historically detected in some soil samples and targeted removal action was performed in mid-2000s.
- Selected areas for sampling based on previous investigations and historical site features
